**TENDON IMPREGNATION TECHNOLOGY
MITIGATES CORROSION AND PROTECTS
POST-TENSIONED TENDONS**

Authorized reprint from: August 2014 issue of the PTI Journal

THE PROBLEM

THE SOLUTION

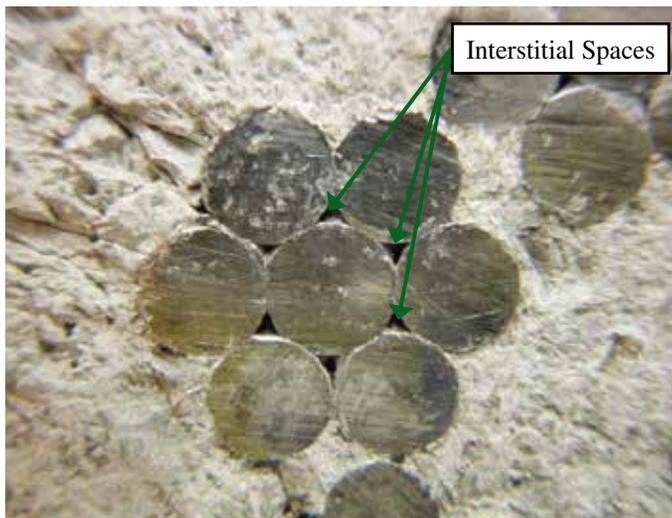
Fig. 3—End view of a single strand from a tendon showing the interstitial spaces between the wires.

The system uses the interstitial spaces between the wires of each strand to deliver (transfer) a unique corrosion-inhibiting tendon impregnation material along the length of the cable. The tendon impregnation material is then able to seep between the wires of the strands, to impregnate the surrounding grout or concrete. In doing so, corrosion activity is reduced or prevented (Fig. 1 through 4).

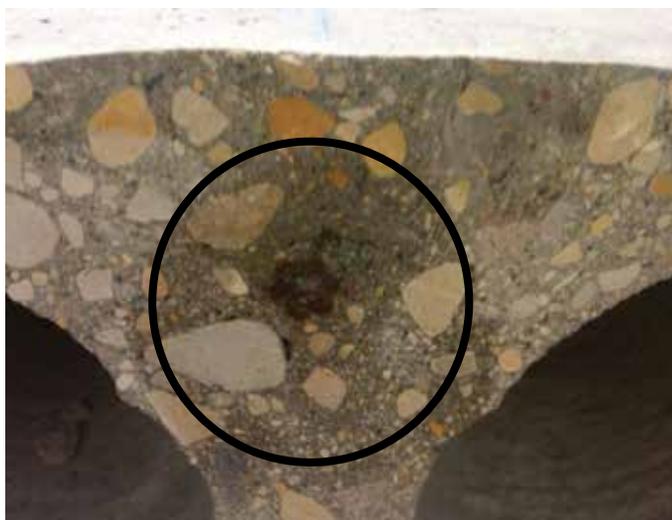
Fig. 4—Concrete surrounding a single seven-wire strand shows a radial pattern of impregnation.

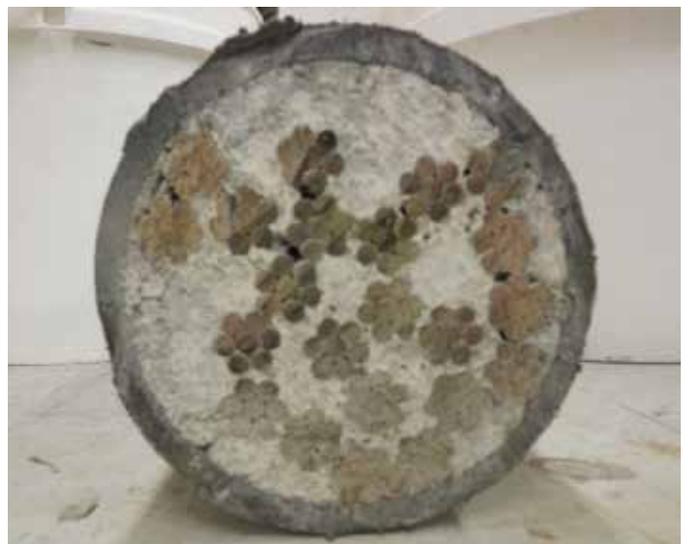
Fig. 5—End view of one FDOT tendon specimen, as received.

The laboratory confirmation was completed on actual bridge tendon specimens provided by FDOT (Fig. 5). The tendon specimens provided to Vector Corrosion Technologies were sections of external tendons which had been removed from a bridge in Florida. Each specimen was 4.5 in. (114 mm) in diameter and contained nineteen 0.5 in. (13 mm) diameter strands. The specimens were well grouted and between 3 and 4 ft (0.9 and 1.2 m) in length.

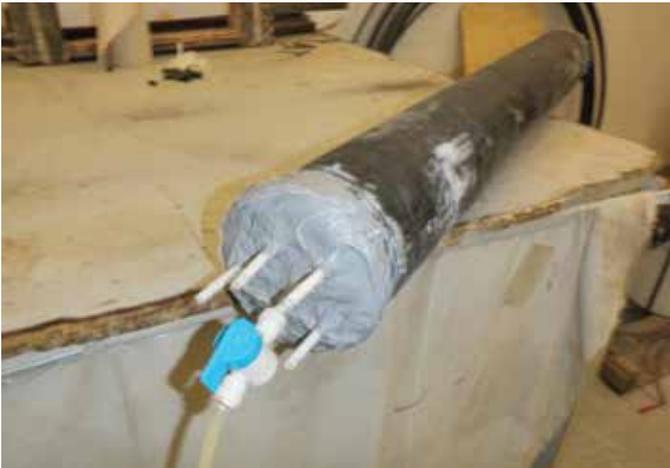
Fig. 6—Impregnation being completed from end of prepared specimen.

The specimens were prepared and impregnated in the lab. Impregnation was completed from the cut end of a tendon specimen, as illustrated in Fig. 6, as well as from the midpoint along the length of a tendon specimen, as illustrated in Fig. 7.

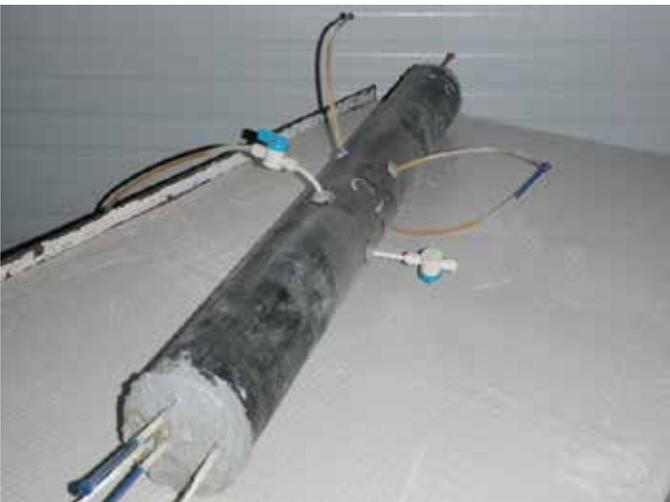
Fig. 7—Impregnation being completed from midpoint of specimen.

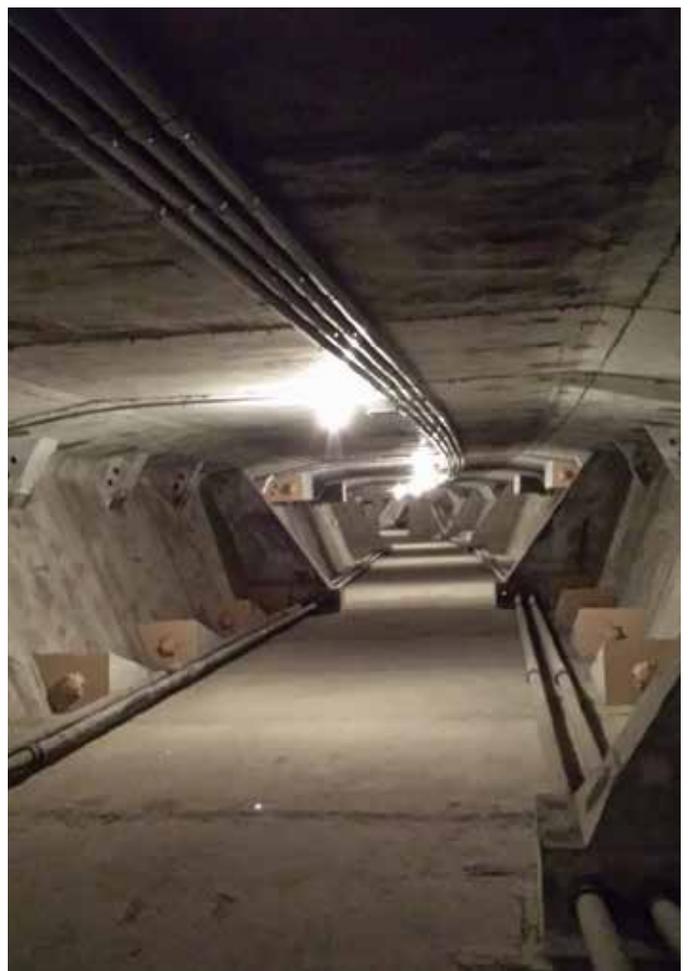
Fig. 9—FDOT cable impregnation trial bridge interior view. External tendons visible along bottom of box section.

The demonstration project was completed on external tendons in a box girder bridge in Florida (Fig. 8 and 9). This structure was chosen for a number of reasons, including:

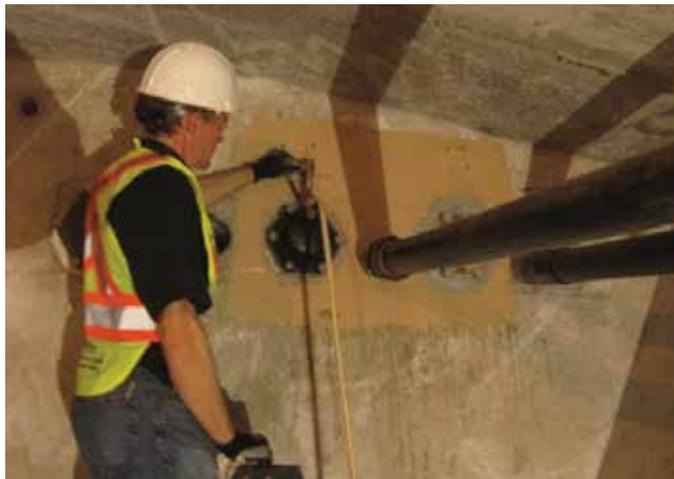
Fig. 10—Impregnation being completed from end of tendon.

In most locations, impregnation was completed from the anchorage end and the impregnation material was pushed through the interstitial spaces until the material reached the opposite end of the tendon (Fig. 10 and 11). Tendons on this bridge varied in length from 235 to 255 ft (72 to 78 m). In one location, impregnation was completed from the midpoint of a tendon.

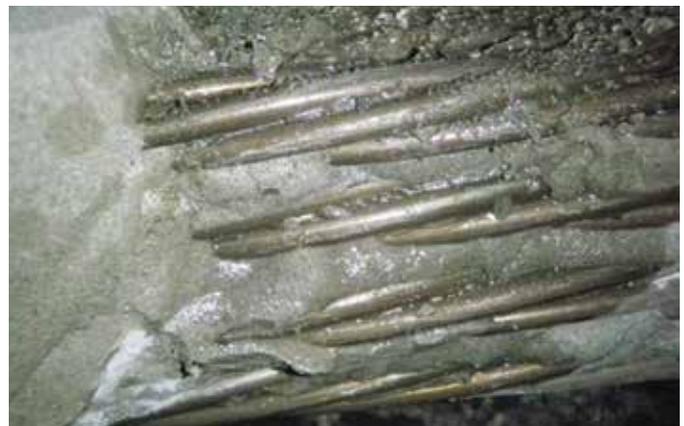
Fig. 16—Impregnation material present within and outside strands.

After impregnation was complete, the duct was opened and grout was removed to confirm the impregnation material had traveled along the length of the strands and had penetrated the grout directly surrounding the strands (Fig. 12 through 16).

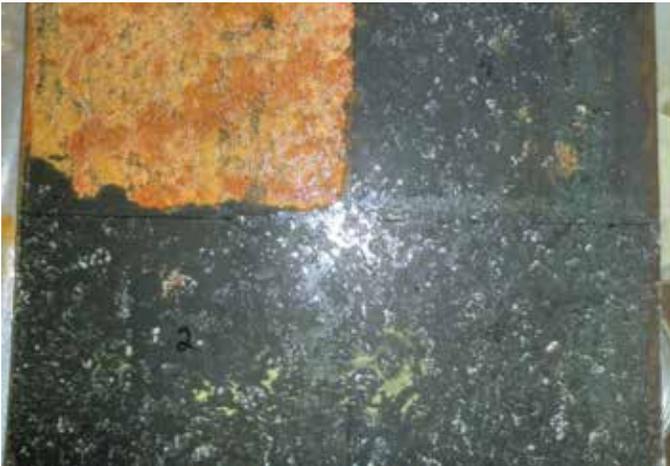
Fig. 17—Steel plate after exposure to salt-spray test Top left—untreated control; top right and bottom—section treated with impregnation material.

two laboratory tests were conducted using treated and untreated bare steel samples. The samples were exposed to a periodic salt-spray. Figure 17 shows treated and untreated

sections of a steel plate after salt-spray exposure. The treated portion of the steel surface was very well protected compared to the untreated portion.

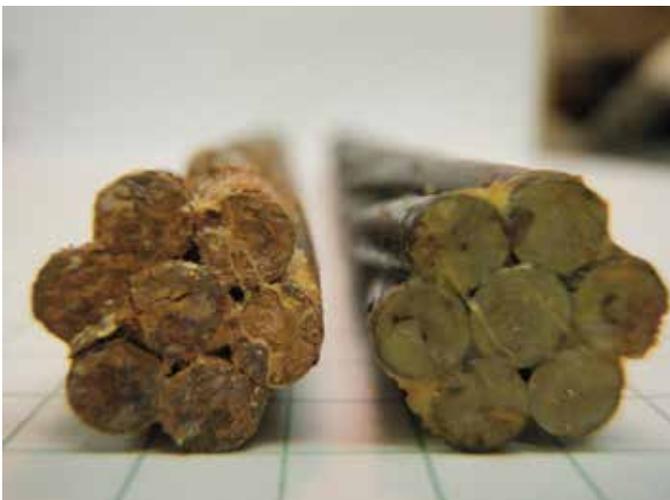
Fig. 18—Post-tensioned strand after exposure to salt-spray test. Left—untreated control; right—treated with impregnation material.

After successful completion of the tests on the steel plate samples, a similar test was completed using treated and untreated sections of post-tensioned strand. Figure 18 shows the results; this second test showed the treated strand to be much more resistant to corrosion.
